## 4.0 ARCHITECTURAL DESCRIPTION, HISTORIC FABRIC AND RECOMMENDATIONS

The eventual goal is to restore the Rancho San Andres Castro Adobe to its appearance between circa 1848 and 1883. The short term goal is to repair, strengthen and retrofit the building and to secure the building envelope which includes the door and window openings.

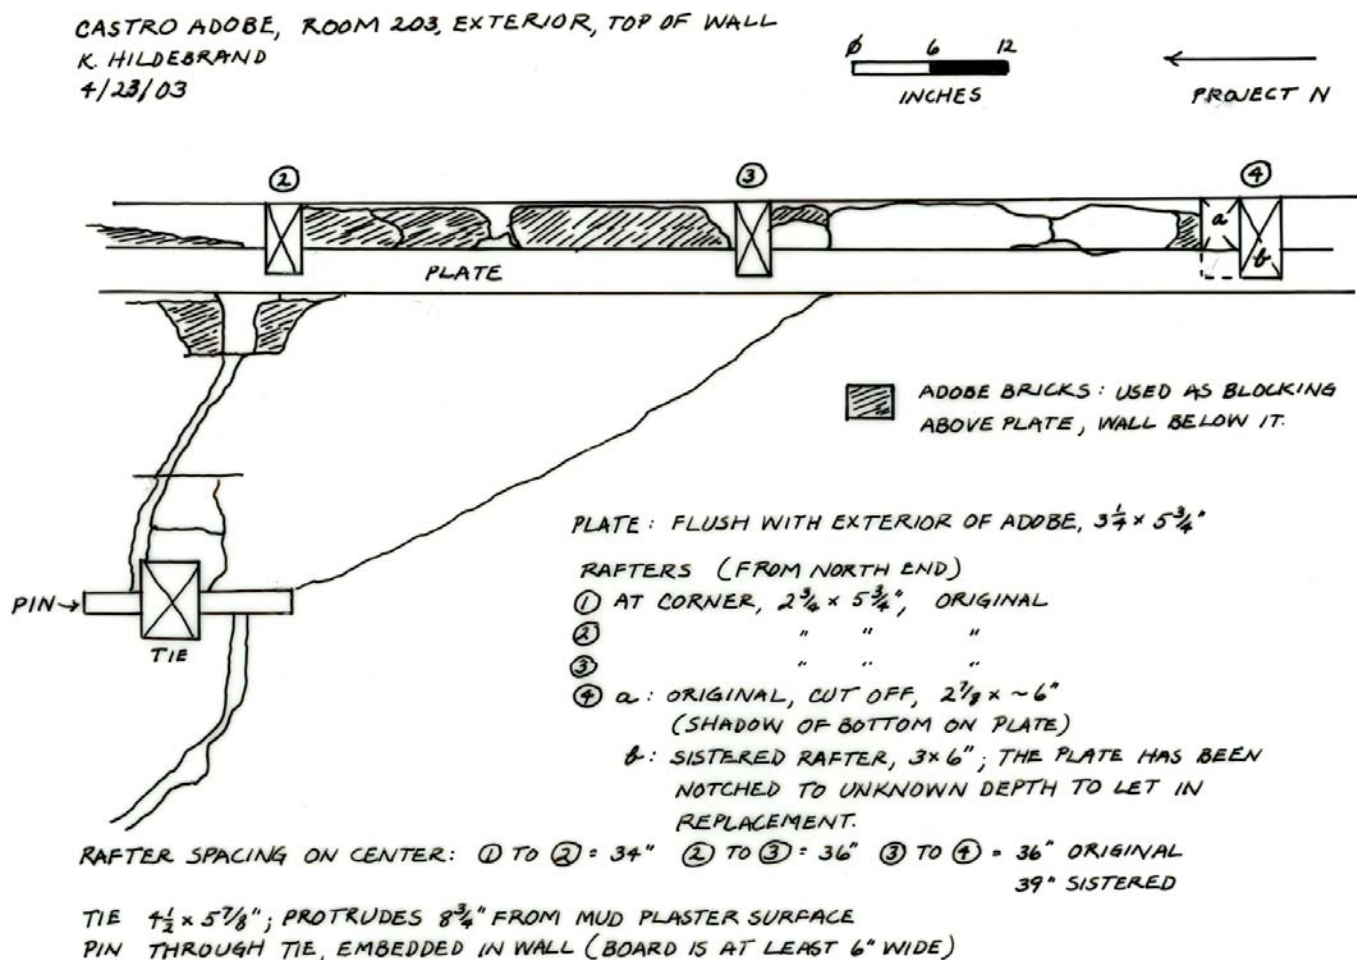
**Figure 4.1** Room 201, Exterior, Top of Wall

Figure 4.1 shows a detail of the top plate near the northwest corner of the adobe on the exterior of Room 201. The plate, 3-1/4 x 5-3/4 inches, is an original element set flush with the exterior face of the adobe wall. The pronounced circular saw marks on the exposed face appear to exactly match those on the under side of the flooring in Room 103.

The adobe bricks forming the wall beneath the plate and the blocking above it are original. Fragments of mud plaster can be found on the wall, plate and adobe brick blocking course with sufficient overlaps to indicate that it was a continuous finish. This was covered with whitewash extending to the top of the wall below the roof. Probably some time later, a 7 1/2" tall fascia board was added that has left a scar below the plate. The existing fascia is 11-3/8" tall, attached with wire nails.

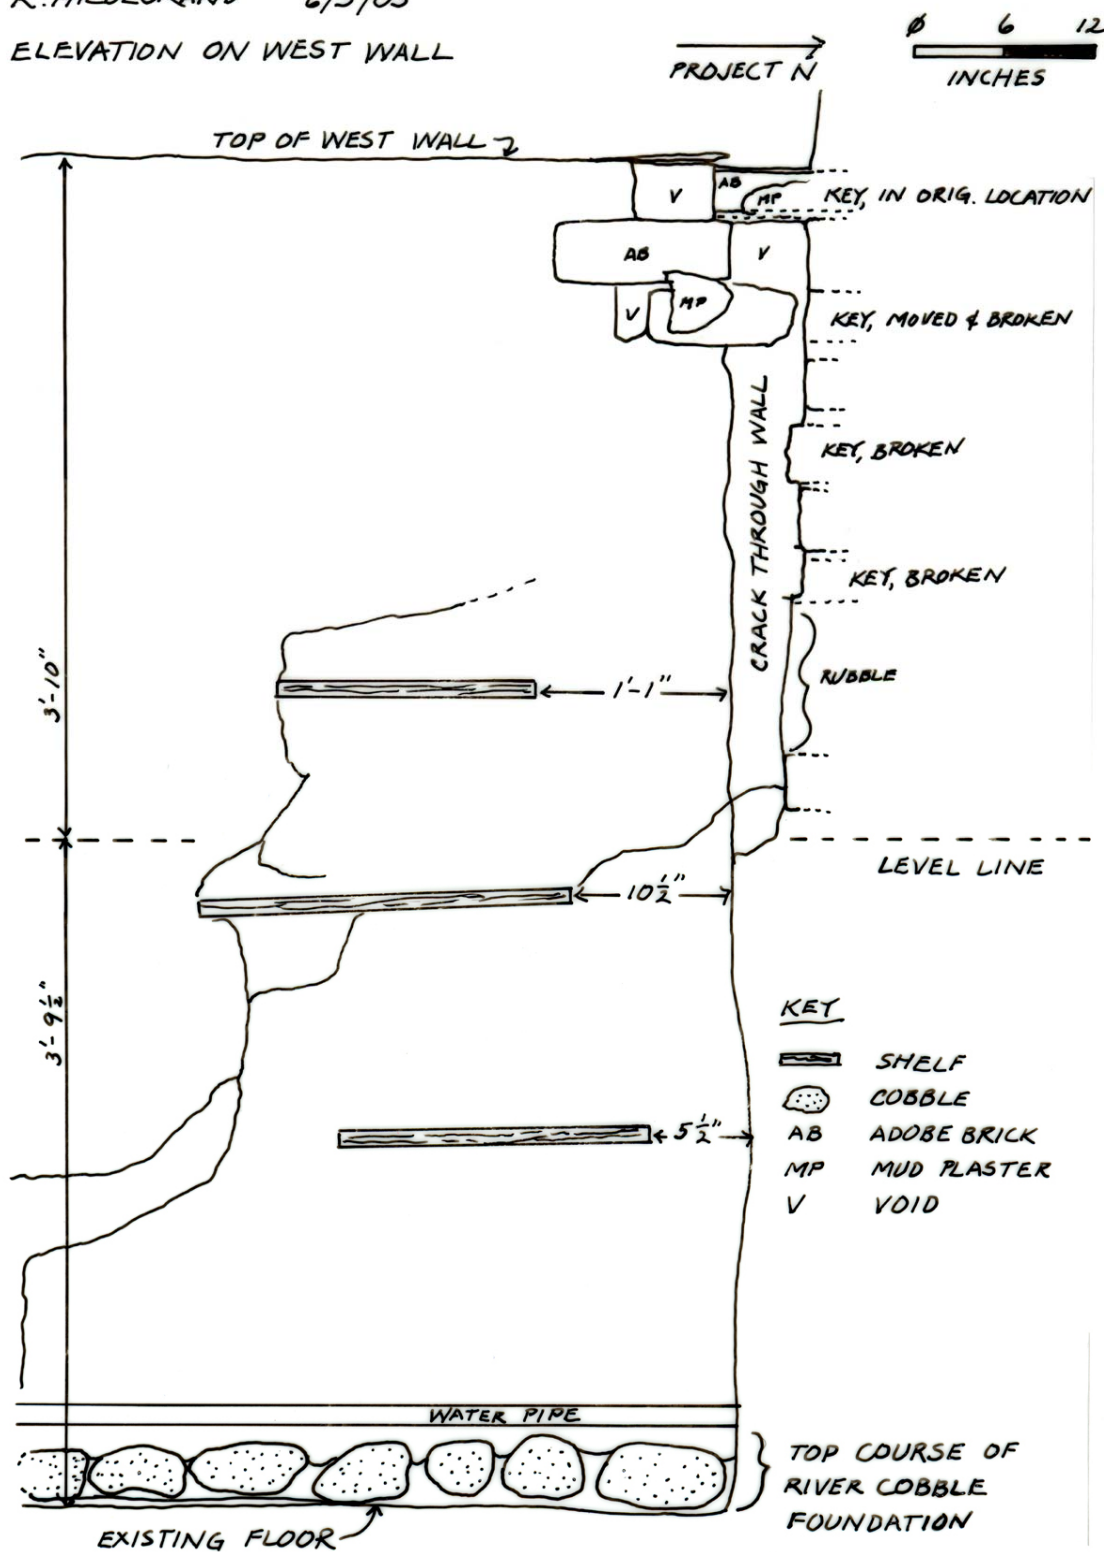
**Figure 4.2** Cocina shelves as embedded in the west wall with northwest corner detail.

CASTRO ADOBE, COCINA, ROOM 101, SHELVES IN NW CORNER  
K. HILDEBRAND 6/5/03

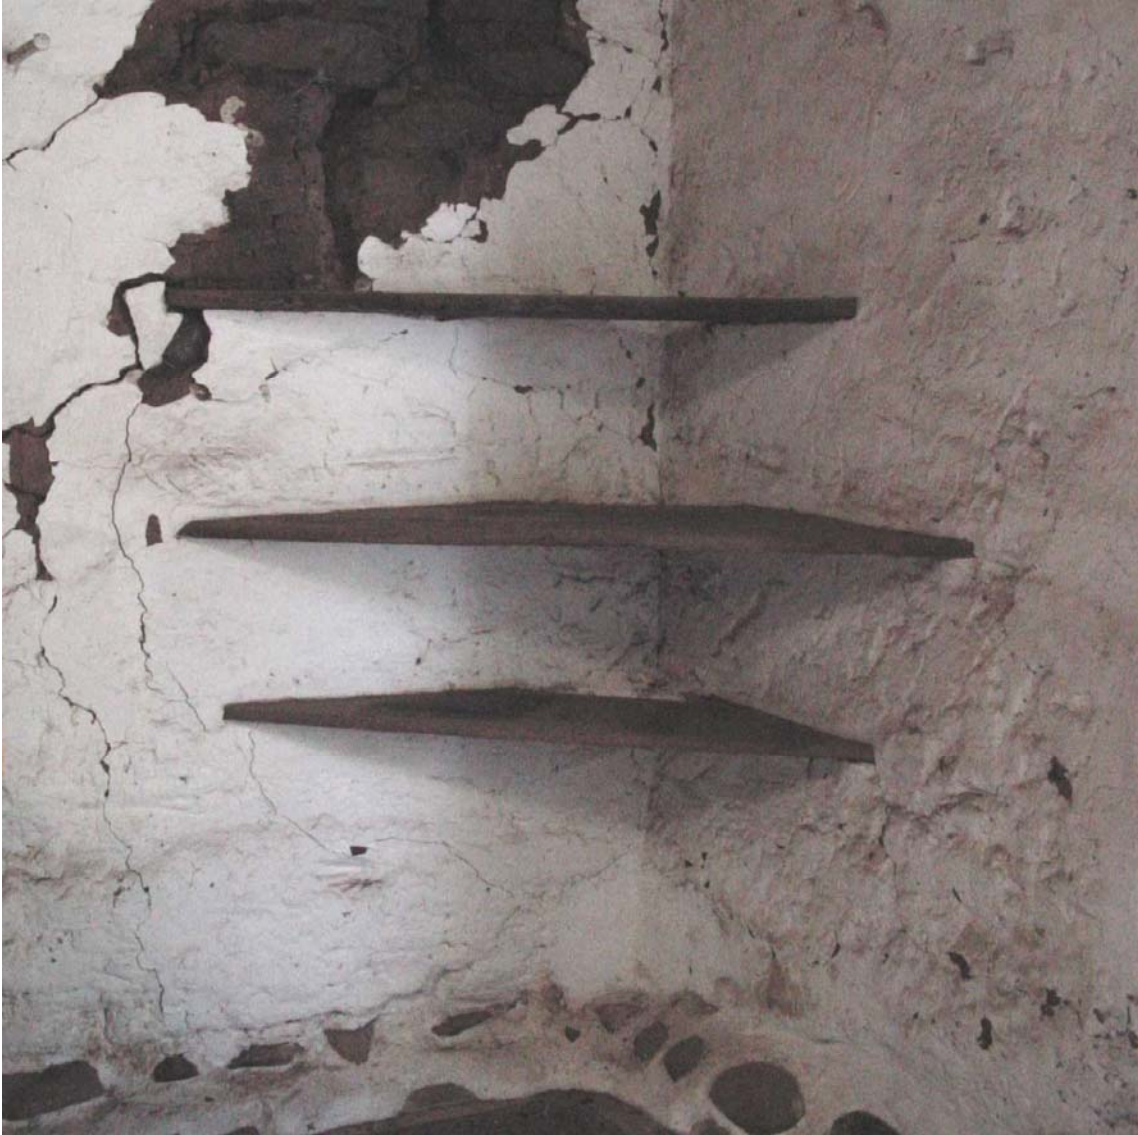
The second set in the northeast corner and the set of recessed shelves in the west wall are all built of one inch thick redwood boards. These were cut long enough to extend the full thickness of the wall, as recorded in an out-of-plane crack in the north wall. They were probably lightly planed, but they are now so worn from use and blackened from cooking fires in the brasero that it is not possible to tell. They were never whitewashed.

**Figure 4.3** Original corner shelves in northeast corner of cocina.

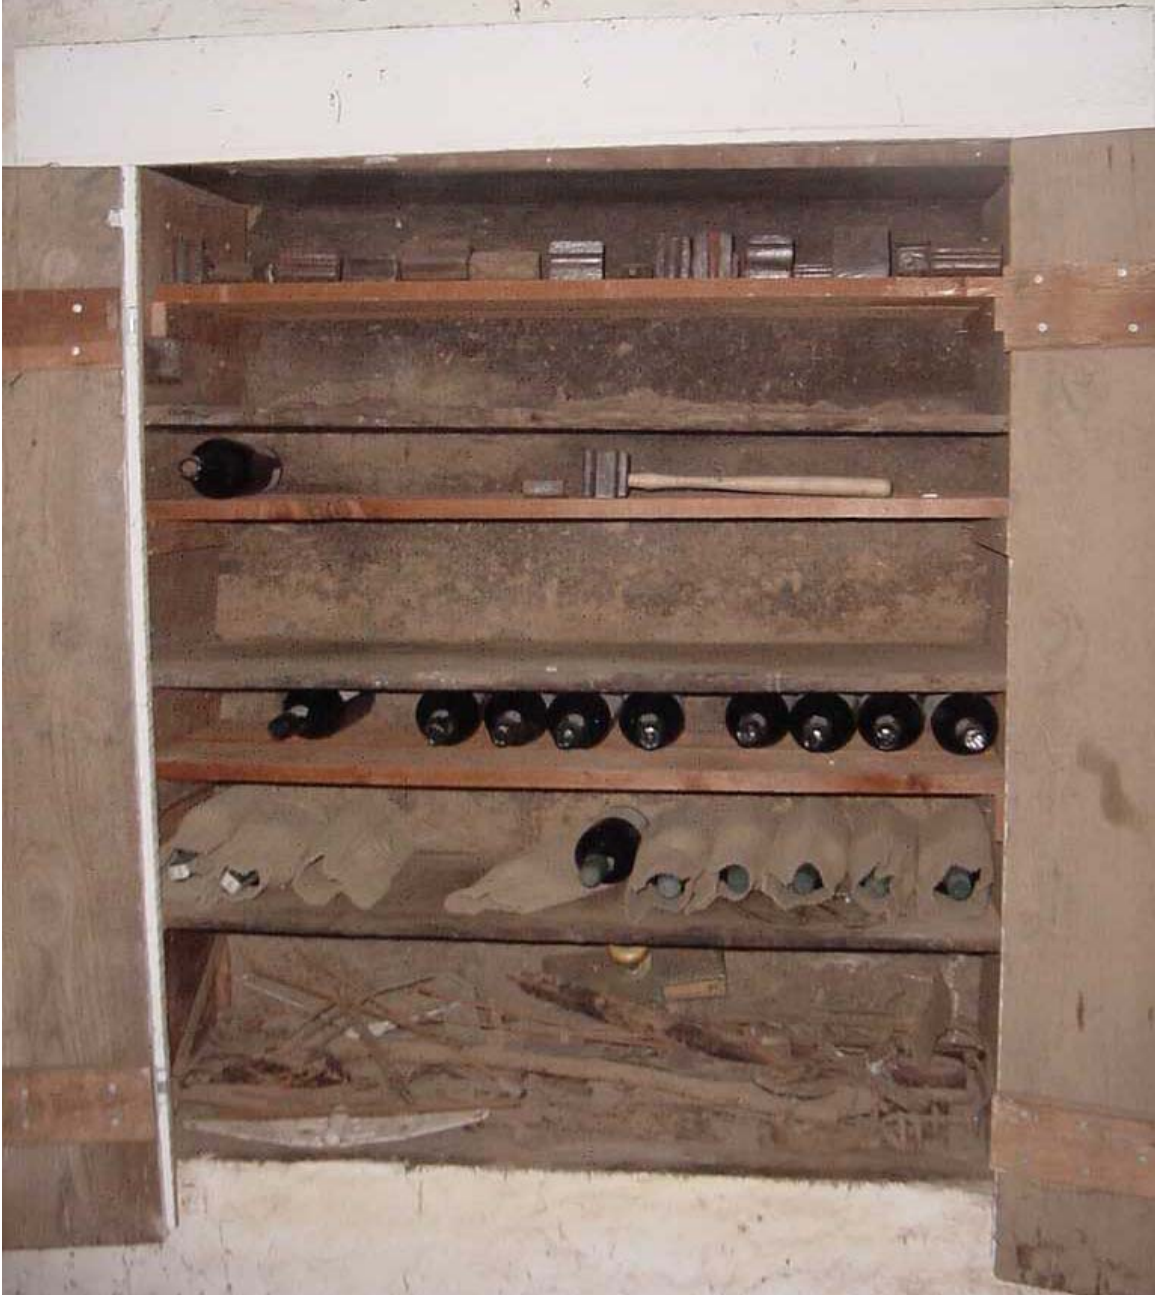
The south wall features an historic *alacena*, typical of Mexican kitchens. It has been modified with wine racks and doors.

**Figure 4.7** Interior of the historic *alacena* with three original shelves and three recent shelves.

**Restoration Recommendations: Remove the asphalt floor, remove the exposed wiring conduit. Relocate the electrical panel. Reconstruct the brasero with its hornilla. Remove the new doors and new shelves of the *alacena* (in-wall original cupboard). Remove the white paint on the walls and expose original blackened surfaces.**

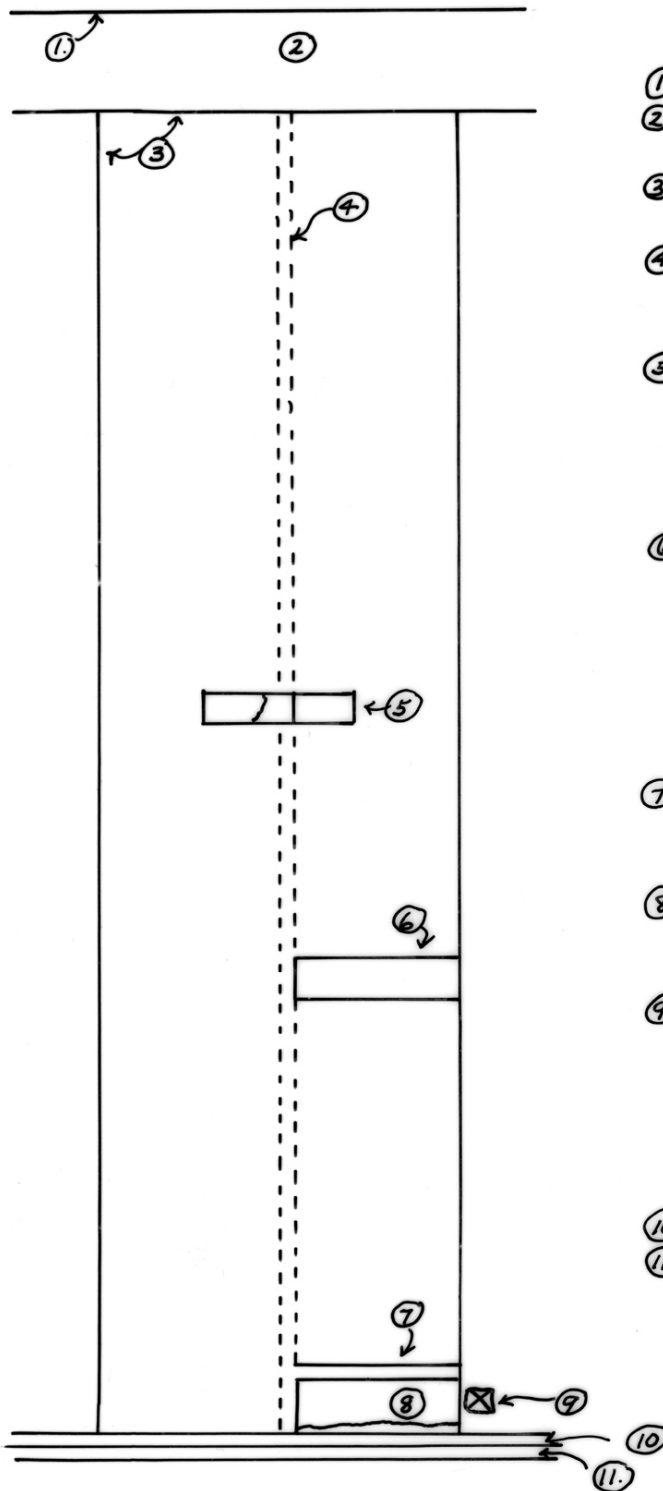
- ① TOP SURFACE OF RAFTER(?)
- ② WHITEWASHED MUD PLASTER EXTENDS TO TOP OF WALL
- ③ INTERIOR SURFACE OF PLYWOOD CLOSET (REMOVED)
- ④ DOUBLE DASHED LINE IS LOCATION OF 1" THICK ORIGINAL BOARD PARTITION
- ⑤ TEST AREA: CEMENTICIOUS PATCH FILLED THE GROOVE IN WALL WHERE PARTITION HAD BEEN LOCATED.
- ⑥ CHAIR-RAIL: DARK GREEN PAINT ON ORIGINAL MUD PLASTER HAD CRISP LINE NEXT TO ORIGINAL PARTITION. LATER COVERED WITH WOODEN RAIL. BOTH 3" TALL.
- ⑦ PAINT BUILD-UP AT EDGE OF WOODEN BASEBOARD. BASEBOARD HT. ~ 5".
- ⑧ PAINTED BASEBOARD. HT. = 4 1/4" (BOTH FROM ORIGINAL FLOOR).
- ⑨ NAILER BLOCK FOR WOODEN BASEBOARD: 1 1/2 x 2 1/2", ROUGH SPLIT SURFACE, REDWOOD, LIKE CHAIR-RAIL BLOCK IN ROOM 203.
- ⑩ ADDED FLOOR, 3/4" THICK
- ⑪ ORIGINAL FLOOR, FULL 1" THICK.

**Figure 4.8** Drawing of original green painted dado rail and black painted base in closet of Room 203, originally part of the sala.

**Recommendation:** Remove (demolish) the partition walls that create these sheet rocked rooms and strengthen the floor. Preserve the evidence shown in the above Figure 4.1.

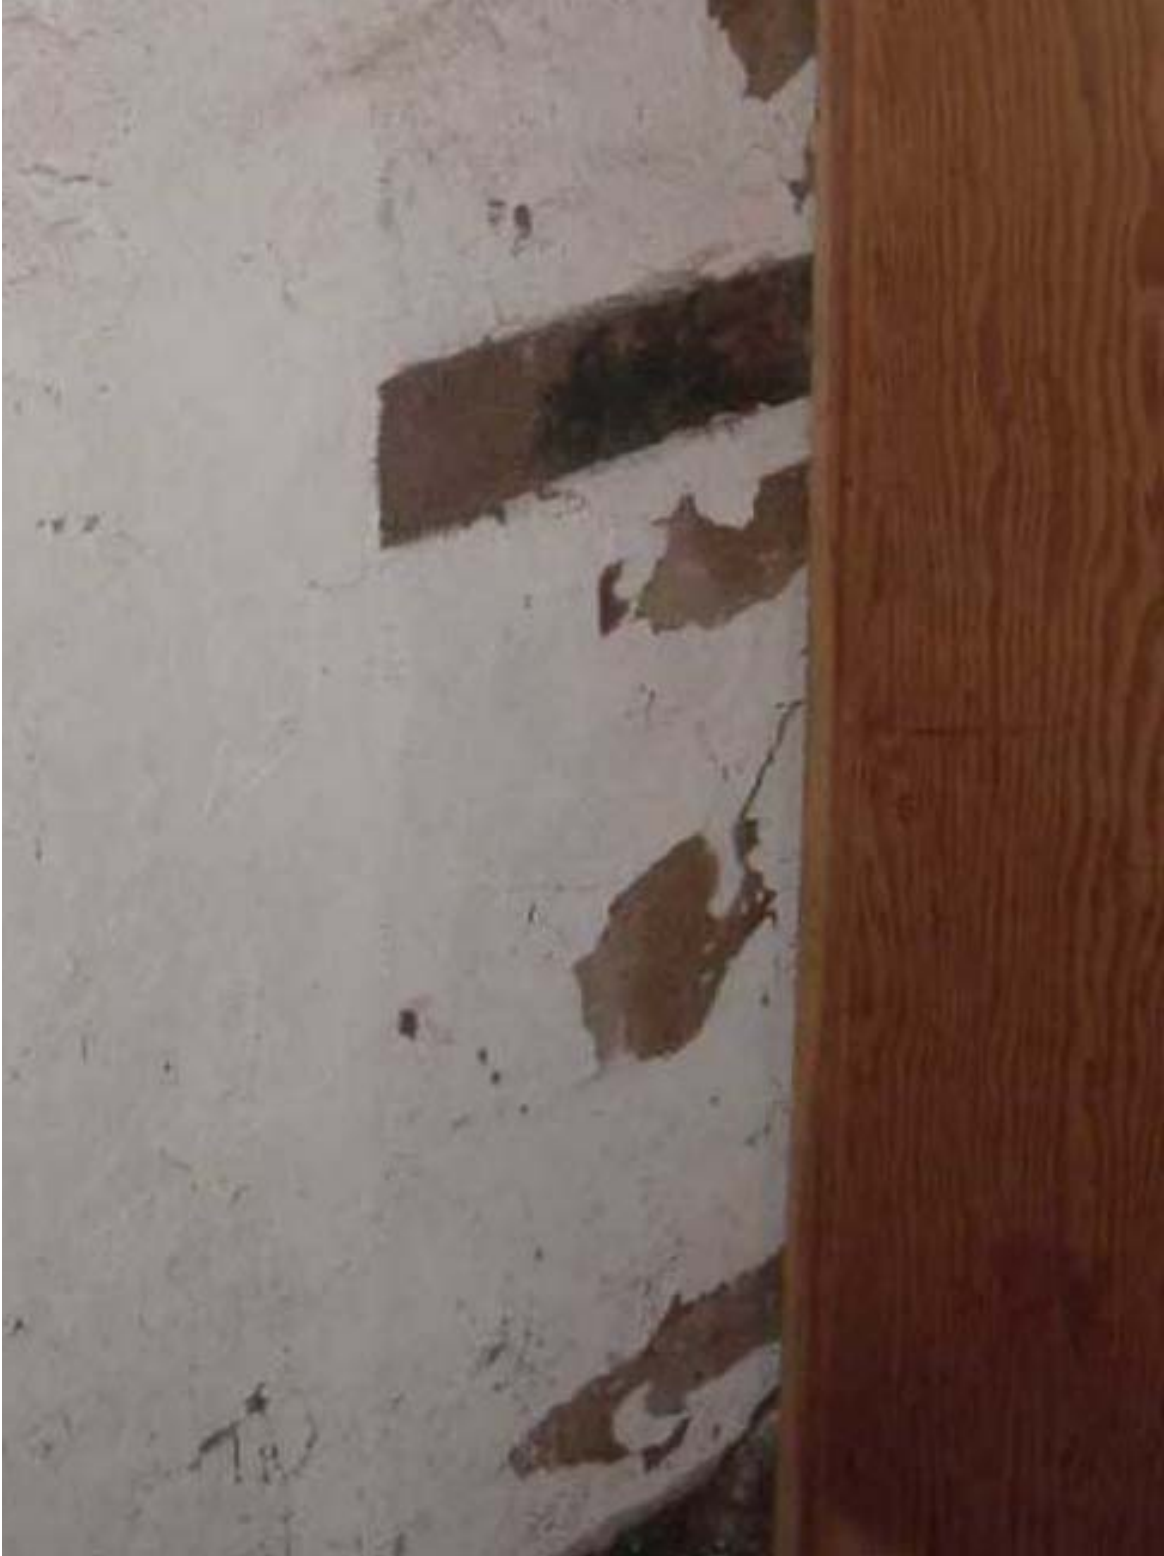
**Figure 4.9** Photograph of original green painted dado rail and black painted base in closet of Room 203, originally part of the sala.

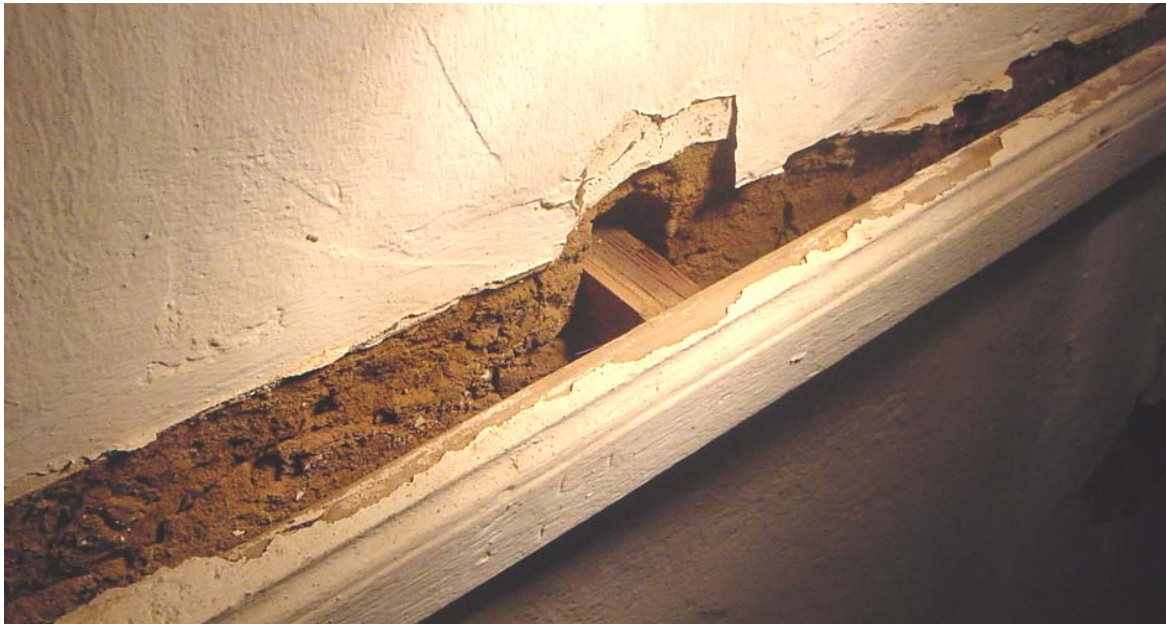
Physical evidence of the attachment of the chair railing indicates that "gringo blocks" or wood nailers were used about 1 ¼" x 2 ¼" wide with square cut nails, suggesting that the wood railings were added by the Castros.

**Figure 4.11** Chair railing in Room 203 with in-wall nailer and green paint behind.

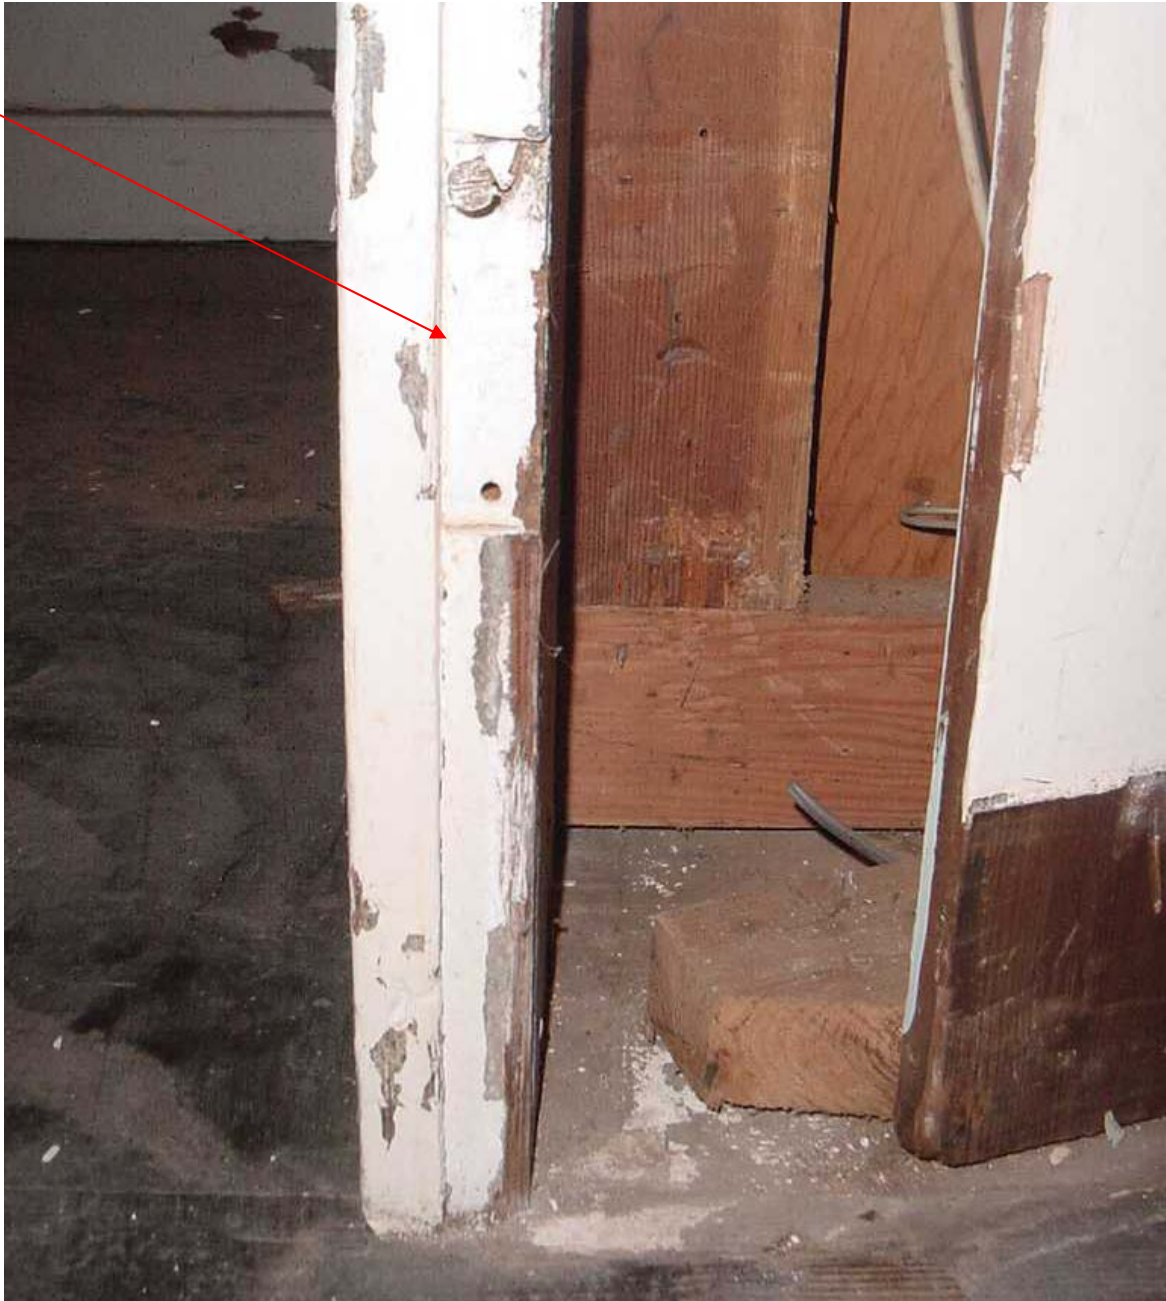
Further investigation of the jambs of the doorway in the partition wall was done to find out the original width of the opening so that it could be restored accurately. The boards above the door had a pronounced paint line where the Paizis top trim was located, but also, a narrow paint line (about 1" ) below on some of them suggesting that they had been turned upside down and reinstalled. This paint line did not continue onto the last two boards to the west which are about 6 ½" wide.

**Figure 4.12** East jamb of partition wall showing original location on floor and hinge scar for double leaf doors in D17, Room 202 (view looking east). The screw is pointless, dating it to before 1850.

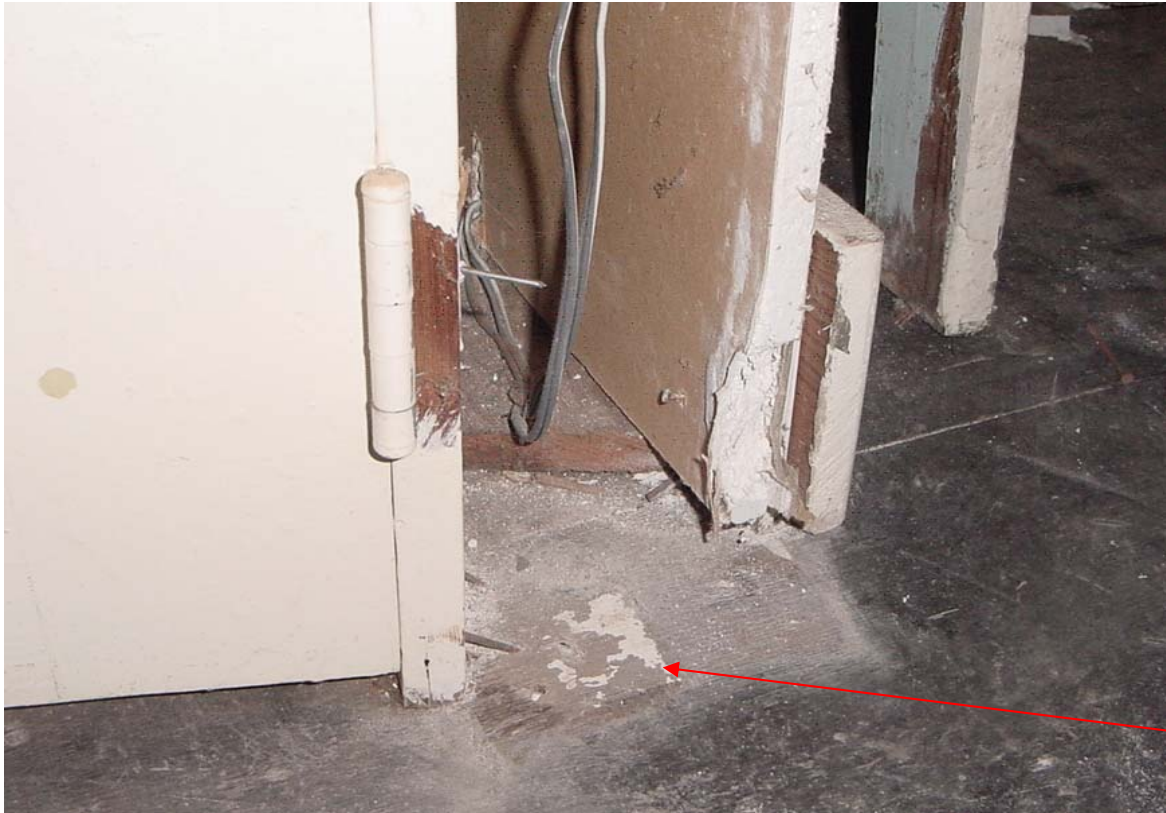
We did not encounter the early west jamb as it had been removed for installation of sheet rock in the water heater closet by the Potters in the 70s. But, we found clear white paint lines on the floor on both the east and west sides of the doorway that indicate that the 1970s bookcase related construction had pushed or forced the partition wall northward about an inch or more. The width of the original opening was 42" which with the small two screw hinges on the east side,

indicates that there were a pair of light weight double leaf doors in the original opening.

**Figure 4.13** West jamb of D17, Room 202, showing original location of wood partition (view looking west).
